RECALL CAMPAIGN BULLETIN

NTB13-035a

VOLUNTARY SAFETY RECALL CAMPAIGN 2013 PATHFINDER OCS SENSORS

APPLIED VEHICLES: 2013 Pathfinder (R52)

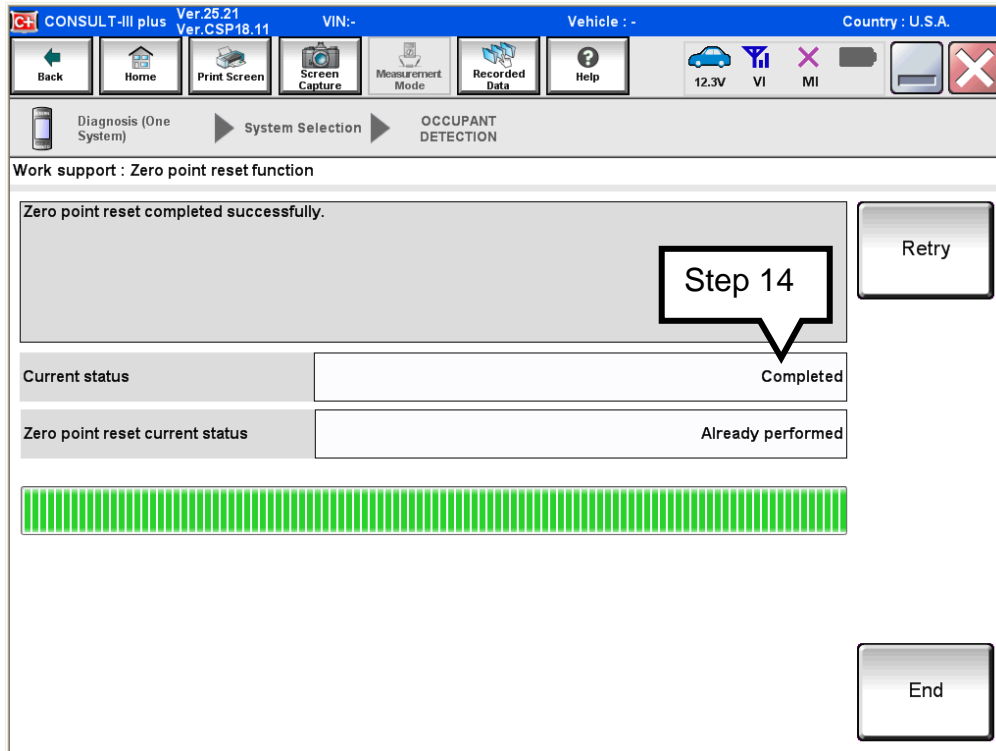
Figure Z7

NOTE: If Zero Point Reset will not complete, it is likely that something in the Service Procedure was not followed exactly as instructed.

NOTE: DTC B1020 is an indication that the 14 mm nuts may be torqued incorrectly.

- a. Turn the ignition OFF.
- b. Make sure all electrical connectors under the seat are **securely connected**.
 - Body harness to seat harness.
 - OCS sensors
 - OCS Control Unit.
- c. Try Zero Point Rest again.
- b. If it still will not complete, an installation process or step was not followed exactly as specified.
 - Recheck / re-perform the OCS sensor installation process.
 - **Pay special attention to the 14 mm nut torque (steps 18 and 19 on page 16).**
