RECALL CAMPAIGN BULLETIN

NTB13-035a

VOLUNTARY SAFETY RECALL CAMPAIGN 2013 PATHFINDER OCS SENSORS

APPLIED VEHICLES: 2013 Pathfinder (R52)

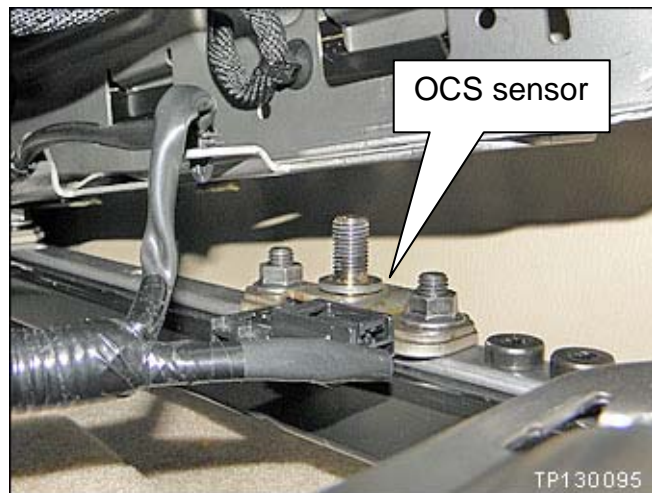
Figure 15

- c. Remove the old sensor.

d. Check the lot code.

NG: Lot code is in this range - 2472 to 3102; replace the sensor

- If the first four digits of the lot code are 2472 to 3102, replace the sensor.

- If the first four digits of the lot code are not in the range above, reinstall the original sensor.

11. Install the front OCS sensor (new or original).

- Torque nuts to:
22 N•m (3.04 kg-m, **16 ft-lb**)
